Part One: Description of the Project Area, Bridge, Bridge Condition, and Proposal

VAN BUREN STREET BRIDGE OVER BRANDYWINE CREEK BRIDGE NO. I-698 PROPOSED SECTION	
--	--

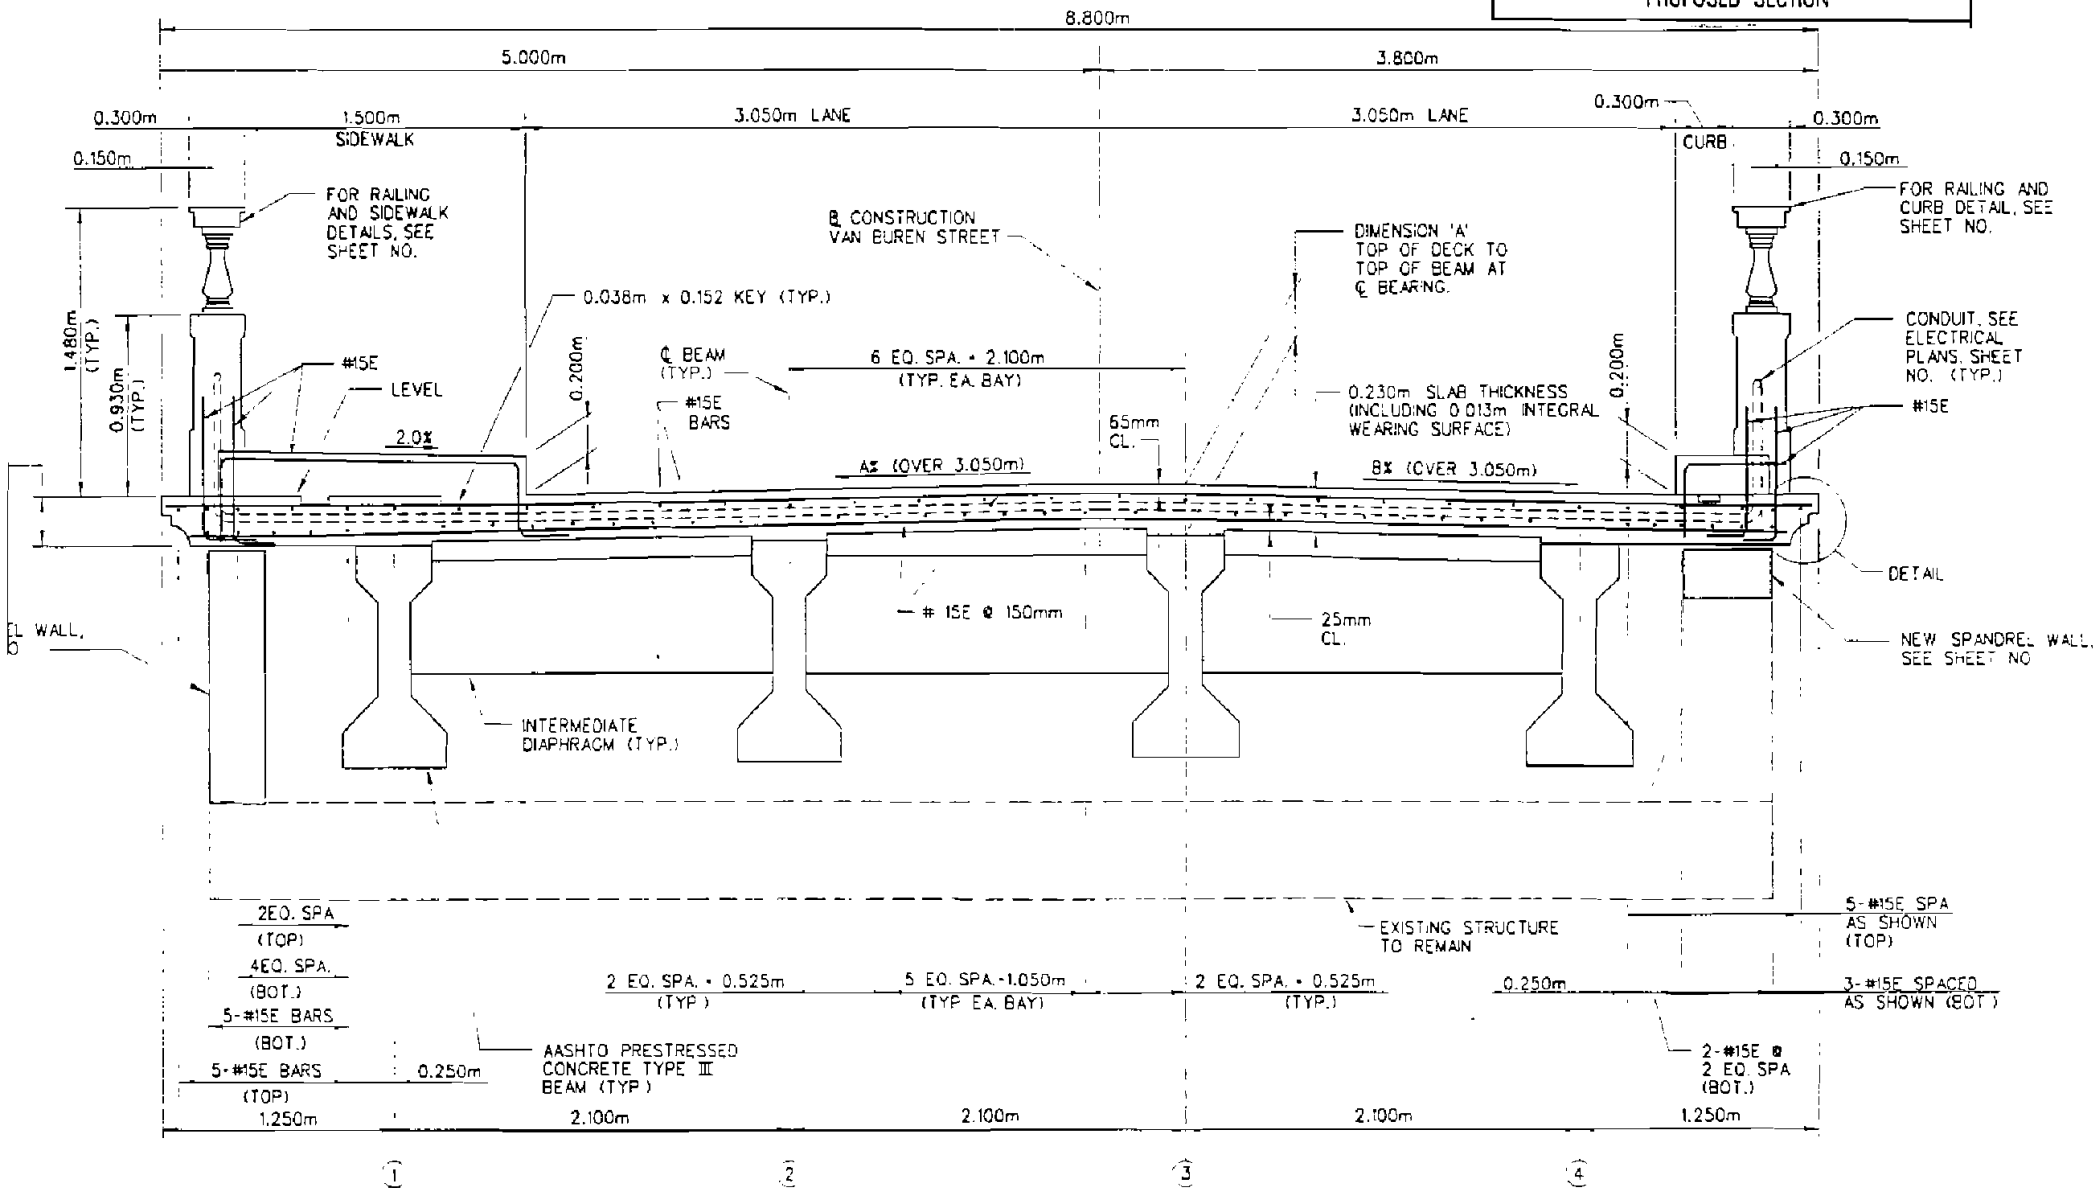
FIGURE 2

TYPICAL CROSS SECTION AT INTERMEDIATE DIAPHRAGM

Based on necessary bridge repair and rehabilitation needs, the extent of the project involves removal of the existing roadway/deck and roadway fill to reconstruct the reinforced arches and spandrel walls. The existing arches will remain as forms as new reinforced concrete I-beams will span between piers. Various details in Figure 2 show cross sections of proposed work. This can be better seen and detailed in Appendix A.

The extent of the project involves an overall repair and rehabilitation scheme that will consist of the removal of the existing deck roadway and sidewalk, encased (abandoned) 48" water main, and earth fill (crusher run) to reconstruct the reinforced concrete arches. The existing arches will remain as forms as new reinforced concrete I-beams will span between piers. The new deck surface will then be poured with concrete.
